THERMINOL

Hello, Therminol. Goodbye, mineral oil sludge.

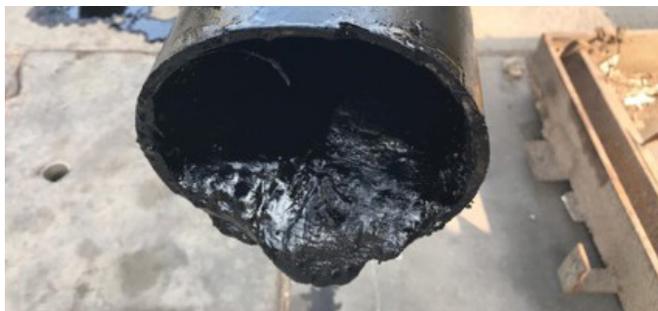
The results of the in-service test sample indicated the mineral oil was extensively thermally stressed. The mineral oil displayed elevated acidity, high viscosity, and insoluble solids. On further inspection, loose carbon particles were found settling in low-lying areas of the heat exchangers, causing the sludge that created inefficient heat exchange.

With mineral oil, loose carbon particles gathered in low-lying areas, causing sludge.

To clean out the sludge and restore system efficiency, the TLC team recommended Therminol FF flushing fluid. To minimize downtime, the Therminol team provided hands-on assistance with lowering the operating temperature and properly mixing Therminol FF into the existing mineral oil. This loosened and entrained the degradation solids within the flushing fluid and helped clean the system without disrupting operations.
